**GUIDELINES ON THE USE OF SCHOOLS AS EVACUATION CENTERS DURING  
PANDEMIC AND THE URGENT REPAIR AND REPLACEMENT OF  
CEILINGS IN SCHOOLBUILDINGS**

**AIDE MEMOIRE**

**URGENT NEED TO REPAIR AND REPLACE  
CEILINGS OF SCHOOLBUILDINGS  
CONSTRUCTED BY FROM 2014-2019**

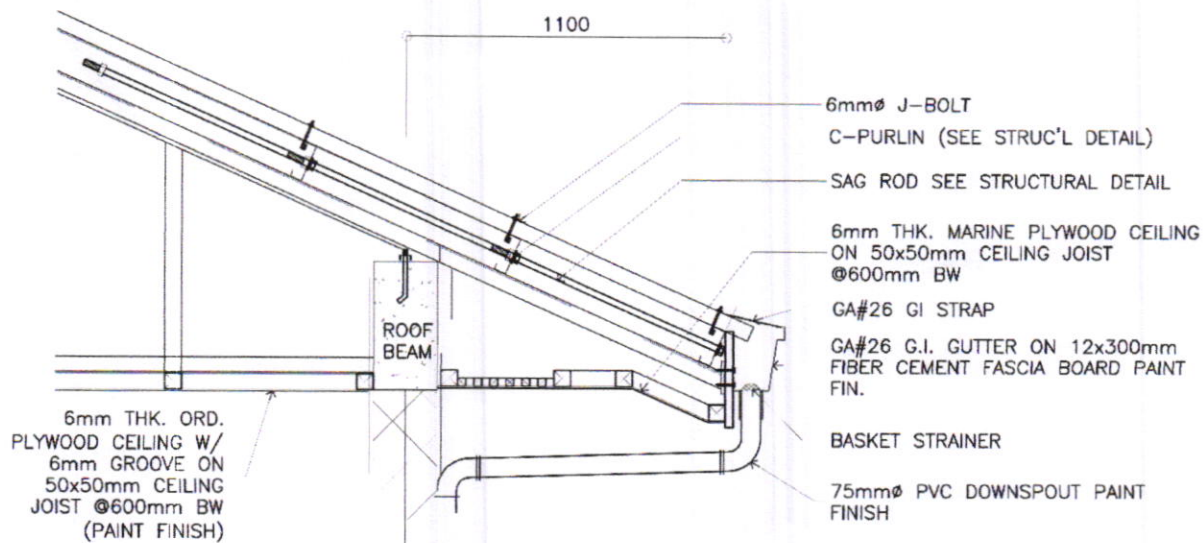
## CEILING DETAIL

SUSPENDED CEILING TYPE

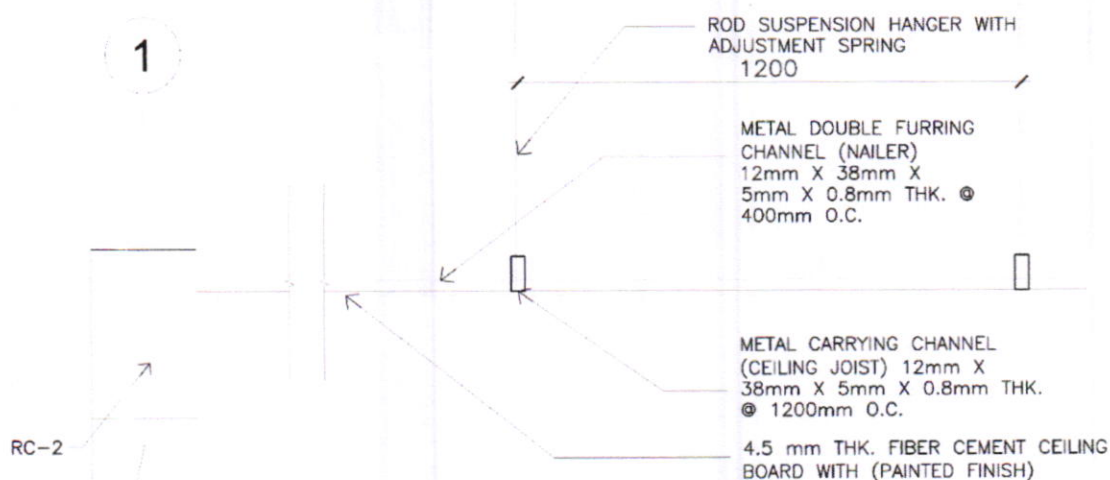
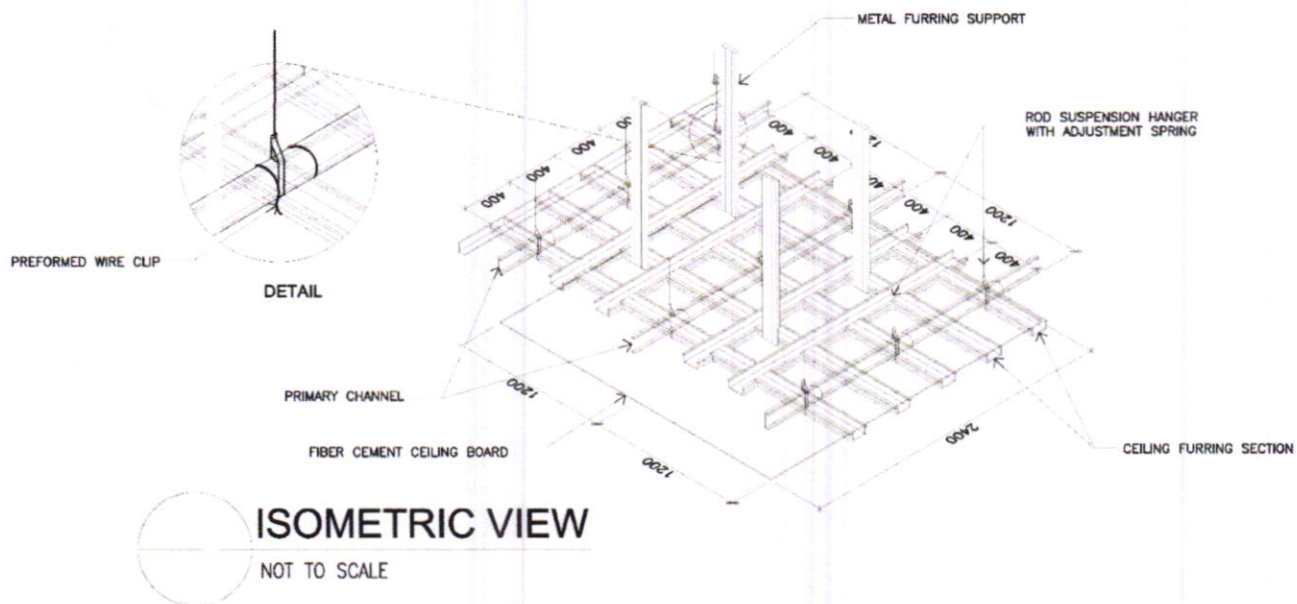
## SECTION

When **DPWH** reviewed the designs of the school buildings in **2014**, the materials used for the ceiling was changed from the conventional wooden type ceiling hangers and joists and marine plywood, to metal furring and fiber cement ceiling board. It can be clearly seen in the design drawings that the spacing of metal furring is set at 400mm X 400mm, using metal carrying C-channels.

**The design specifications were apparently not followed in actual construction: not only were metal C-channels spaced farther apart, there was inadequate and fewer metal furring supports/hangers, as evidenced in the pictures of collapsed ceilings shown in the succeeding pages of this document.**

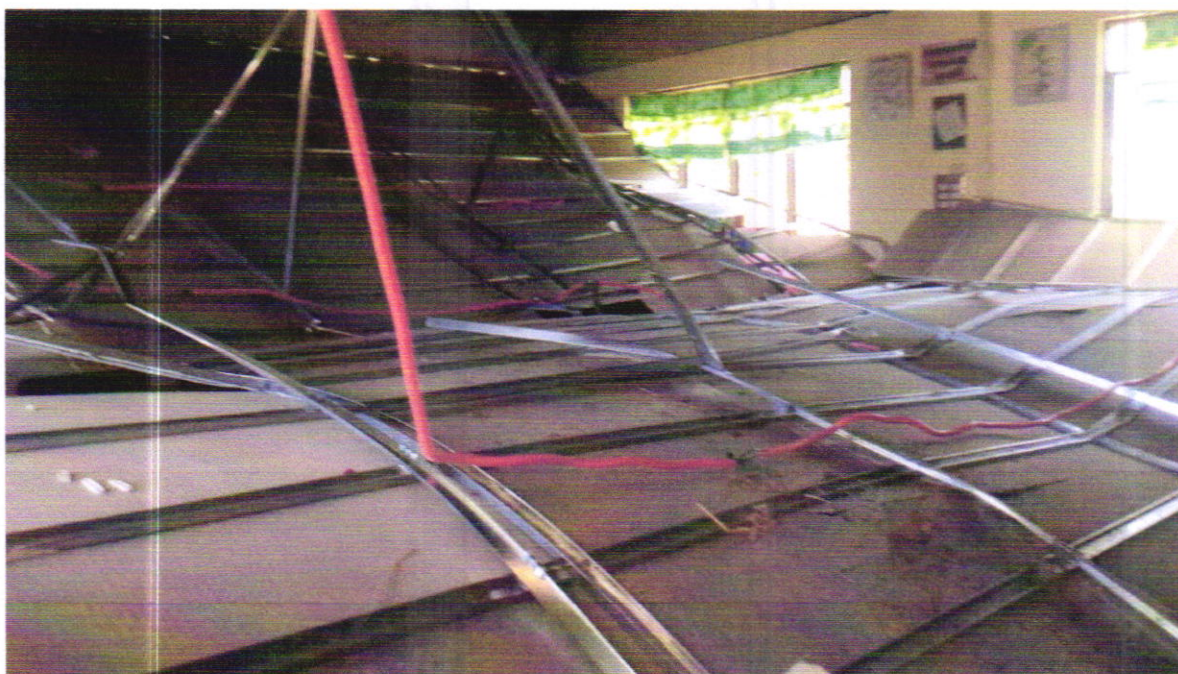
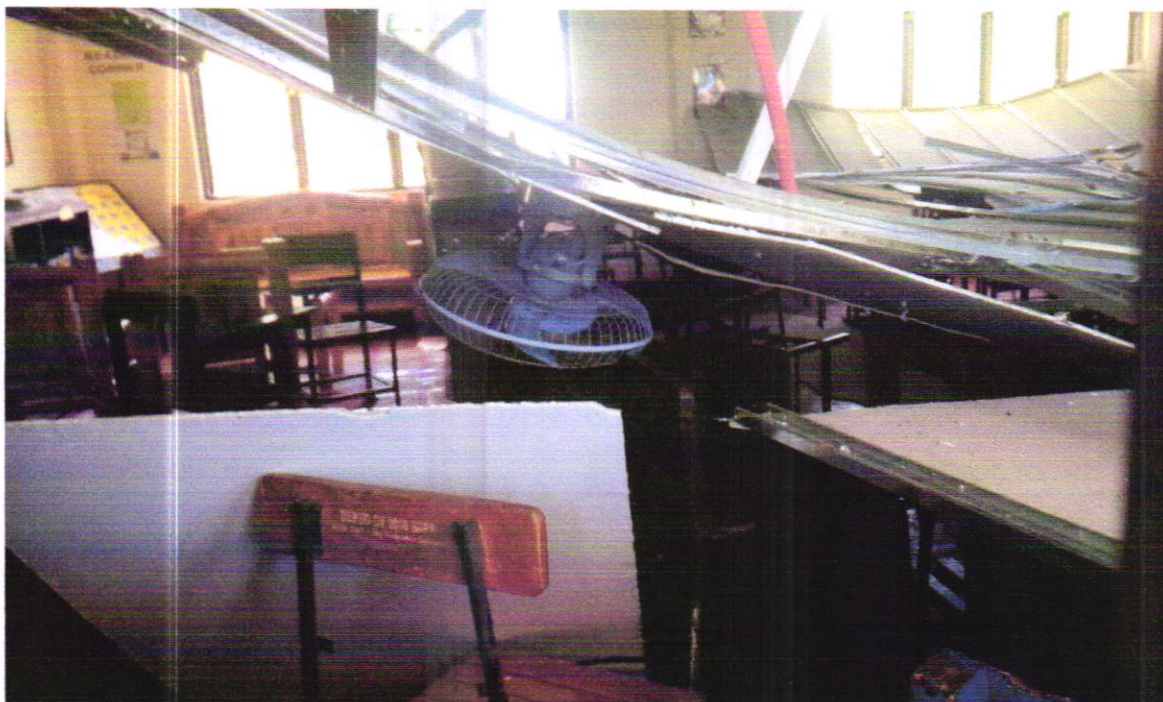
The **first incident of collapsed ceiling was reported in Ramon de Santos NHS, Cuyapo, Nueva Ecija.** The incident happened in **November 2017 under normal weather condition.** The said incident was broadcasted in local media outfits which led the DPWH contractor to shoulder the expenses of hospitalization and medicines of injured students and the reconstruction of the collapsed ceiling without any additional cost to the government.

Incidences of collapsed ceilings are being reported to the DPWH Central Office for immediate and proper action. **For those projects that are still under warranty, contractors of DPWH were instructed to immediately replace damaged ceilings without any additional cost** to the government.

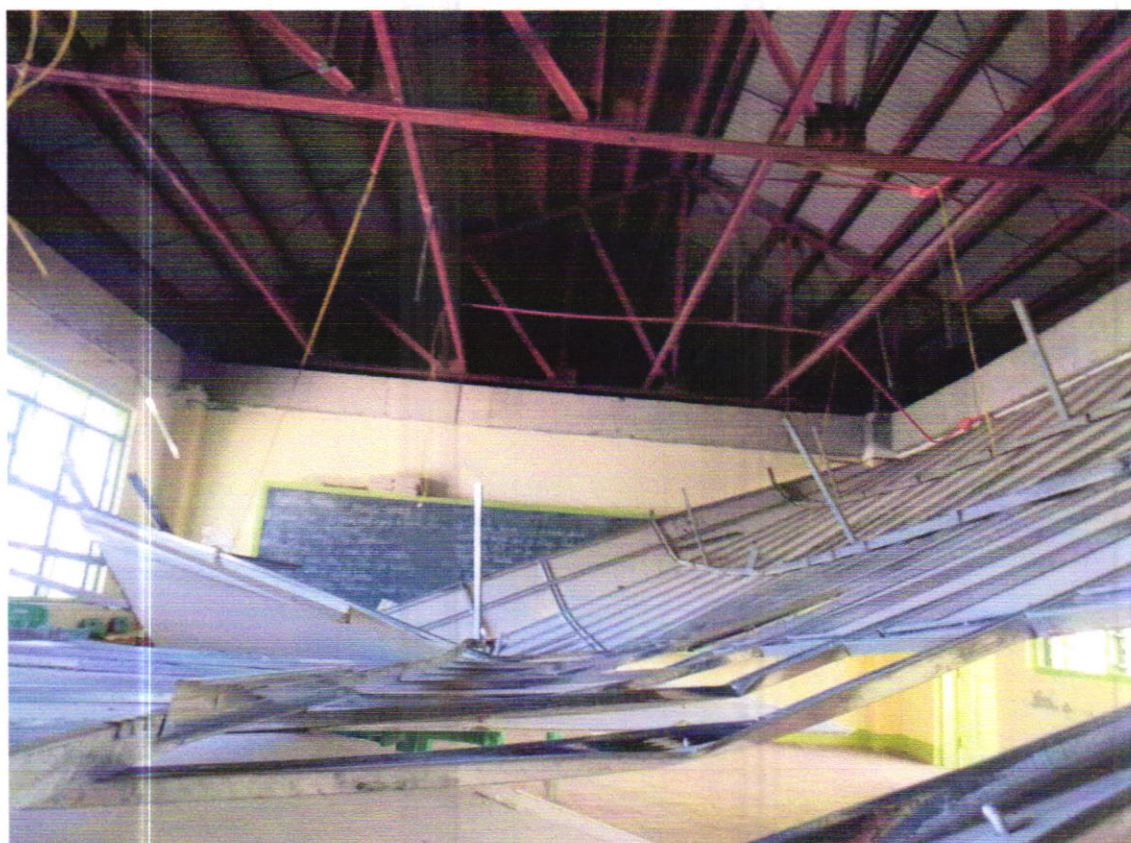
### **Domingo Lacson National High School**

**Several incidents followed and were recorded by the Regional and Division Offices of DepEd particularly after a series of earthquakes and other natural calamities struck the country.**

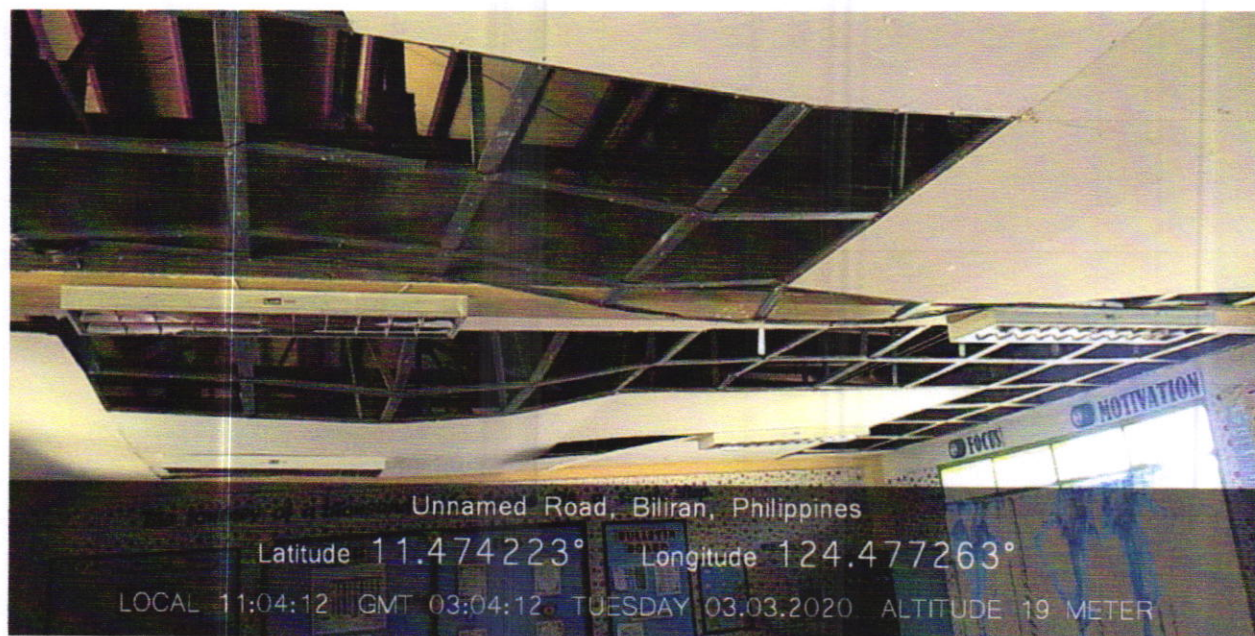
## **Collapsed Ceilings due to Earthquakes**

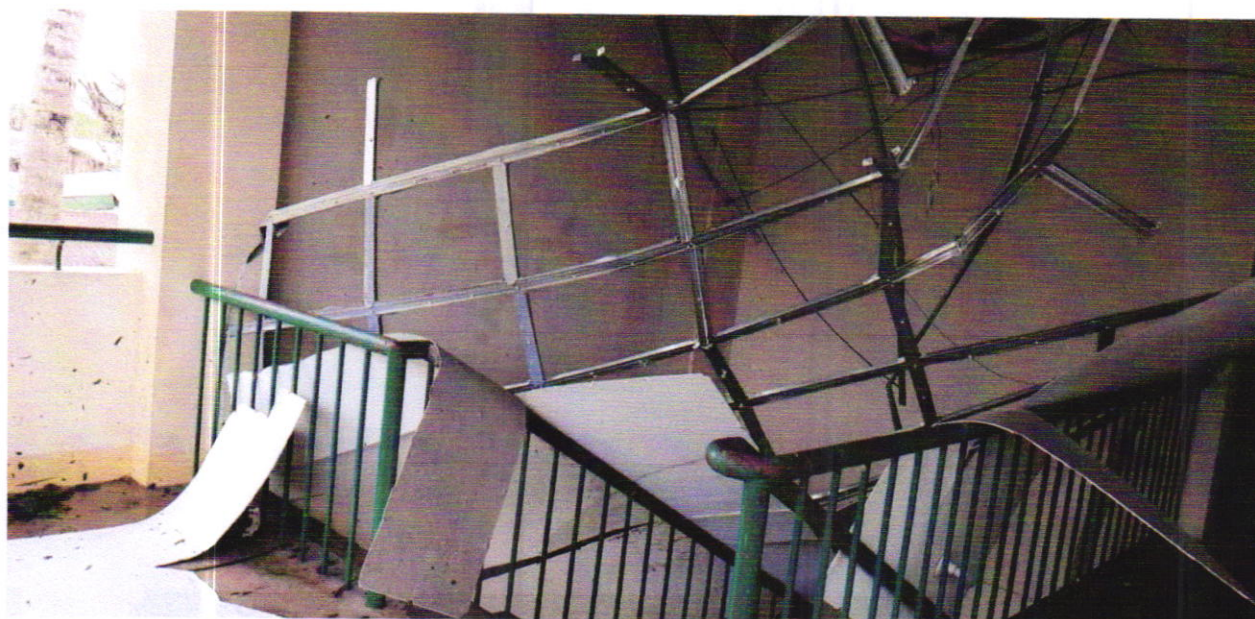
## **Collapsed Ceiling due to Typhoons**

Matacon NHS, Albay collapsed ceiling due to Typhoon Tisoy

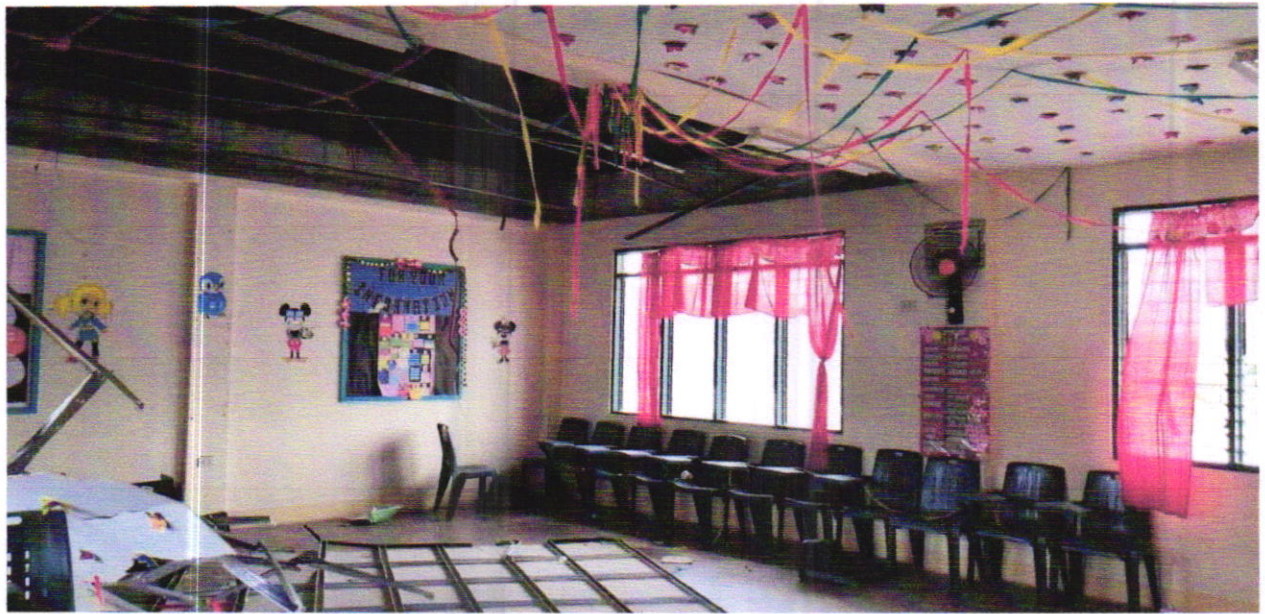
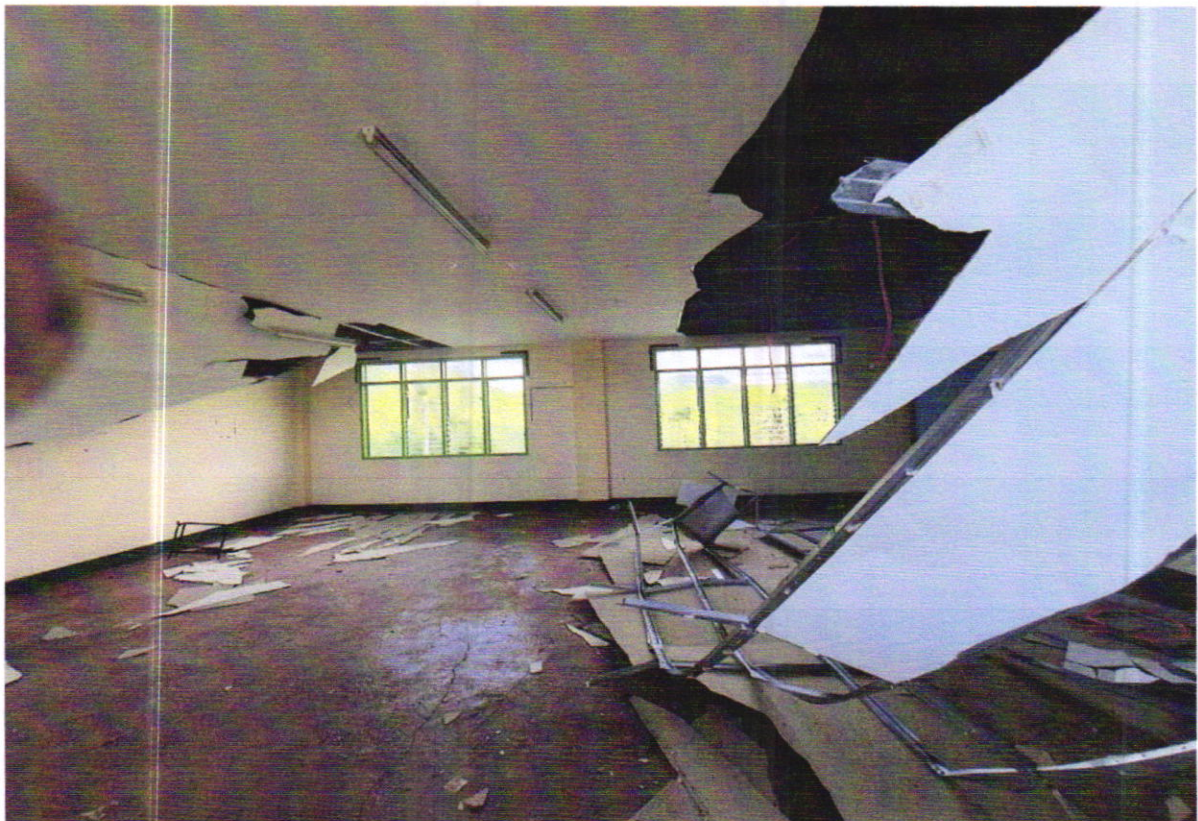
However, **the series of earthquakes that happened in Cotabato, Surigao, Davao, Batanes; of typhoons Ursula, Tisoy, Dodong, Usman, Amang, Vinta, etc.; and the Taal eruption all resulted to collapsed ceilings as regular featured damages.** Had there been classes during those times, the injuries of learners and teachers would have been enormous.
